EcoPhi Case study

Remote monitoring of 450 kWp grid-tied C&I project in Kenya

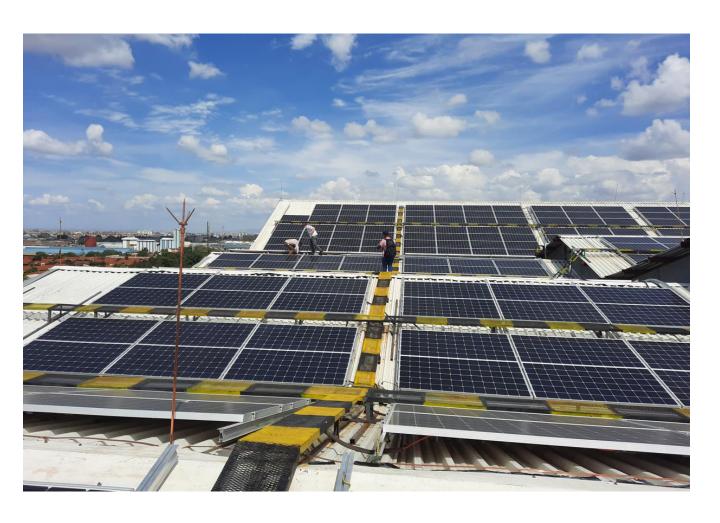
EcoPhi is responsible for the remote monitoring of the system. A Pro Box was installed here, which is able to track the inverters as well as additional sensor data and handles the regulation to prevent the system from feed-ins.
